CONTENTS

No. 3

DUTIES OF AIRCRAFT ENGINEERS LICENSED IN CATEGORIES "A" AND "C"

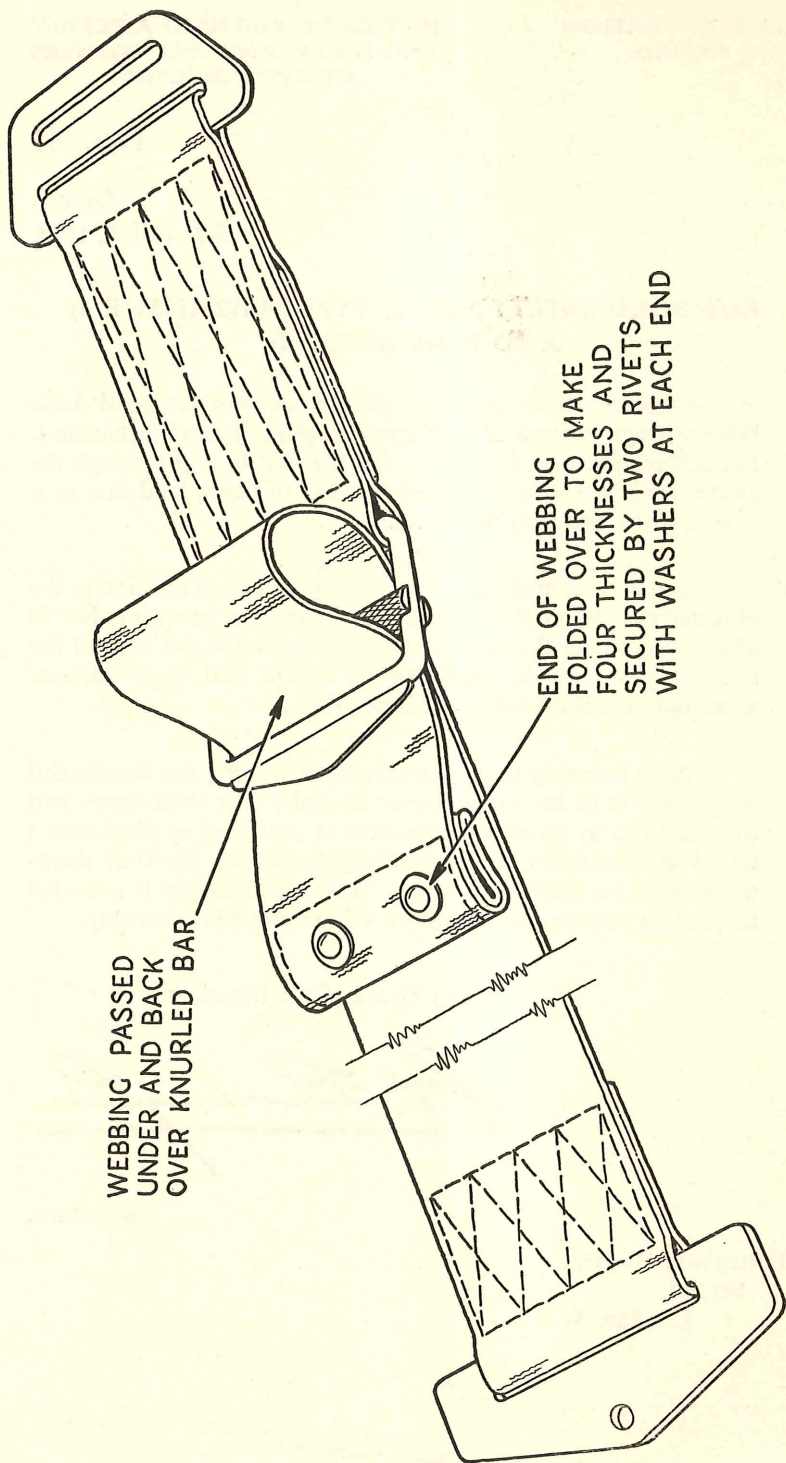
WEBBING PASSED
UNDER AND BACK
OVER KNURLED BAR

END OF WEBBING
FOLDED OVER TO MAKE
FOUR THICKNESSES AND
SECURED BY TWO RIVETS
WITH WASHERS AT EACH END

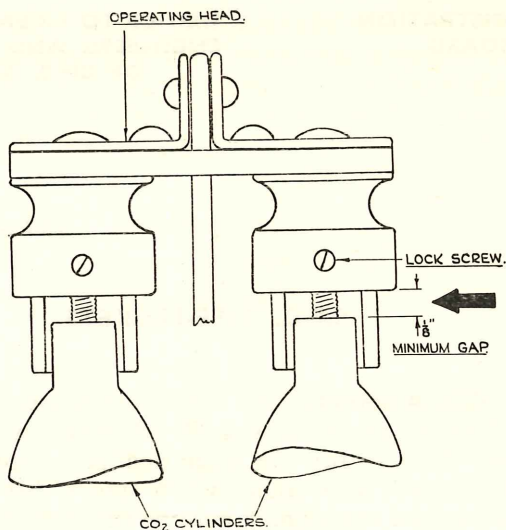
FIGURE 1

FOR TOPPING UP

██████████ PUSH DOWN
VALVE WITH MOUTH
██

TYPE 47 LIFEJACKET.
NOTE: TYPE 45 LIFEJACKET HAS A SINGLE
CYLINDER WITH A MODIFIED OPERATING HEAD.

1.1 Remove the CO₂ assembly from the jacket and check the clearance between the bottle-neck and holder, as illustrated in Figure 1, overleaf.

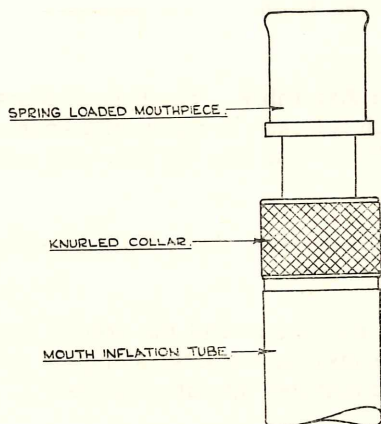
FIGURE 2

TYPE 47 LIFEJACKET, MK. 2.
MOUTH INFLATION ASSEMBLY.

2.1 Tighten the knurled collar down fully to the position shown in Figure 2, overleaf.
